April 10, 2008

**Subject: Tavern Road Culvert Improvement Project – Biological Report
URS Project Number 27657061**

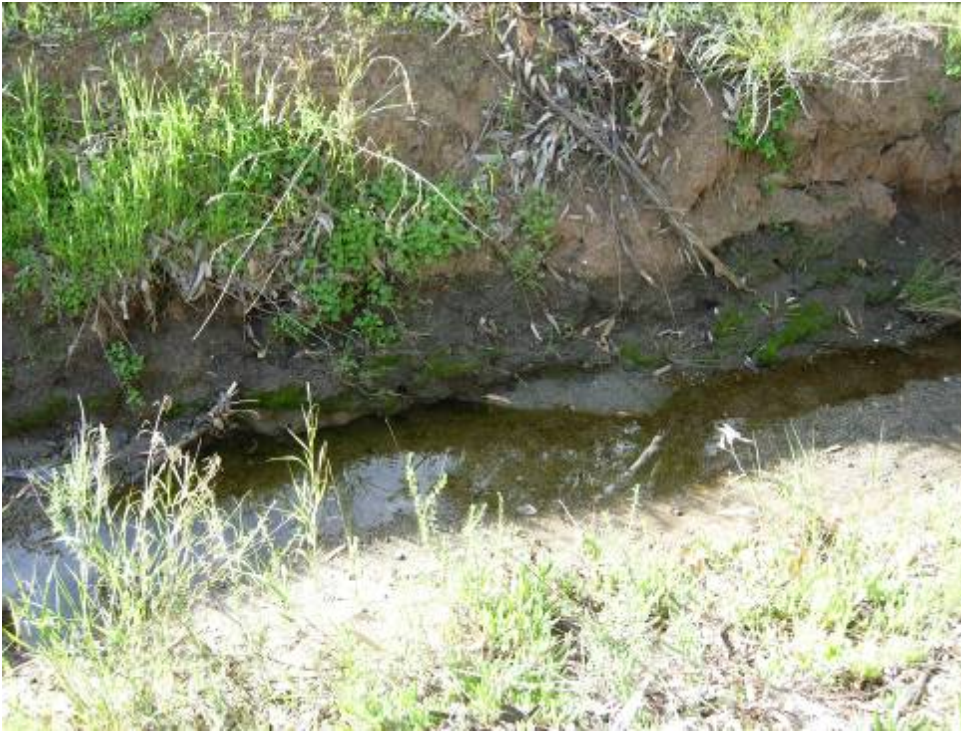
Photograph #1

Shows the lack of vegetation of the OWUS on the East side of Tavern Road.

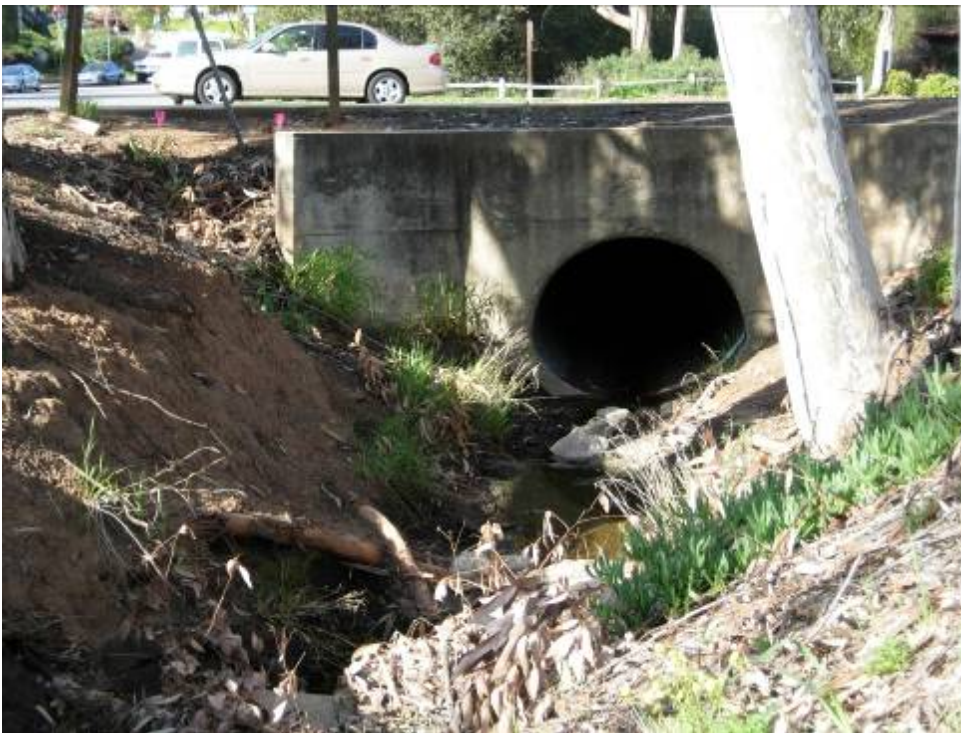
Photograph #2

Shows the culvert that is located on the East side of Tavern Road and the slope of the channel. The channel runs through the culvert in a Northeast to Southwest direction.

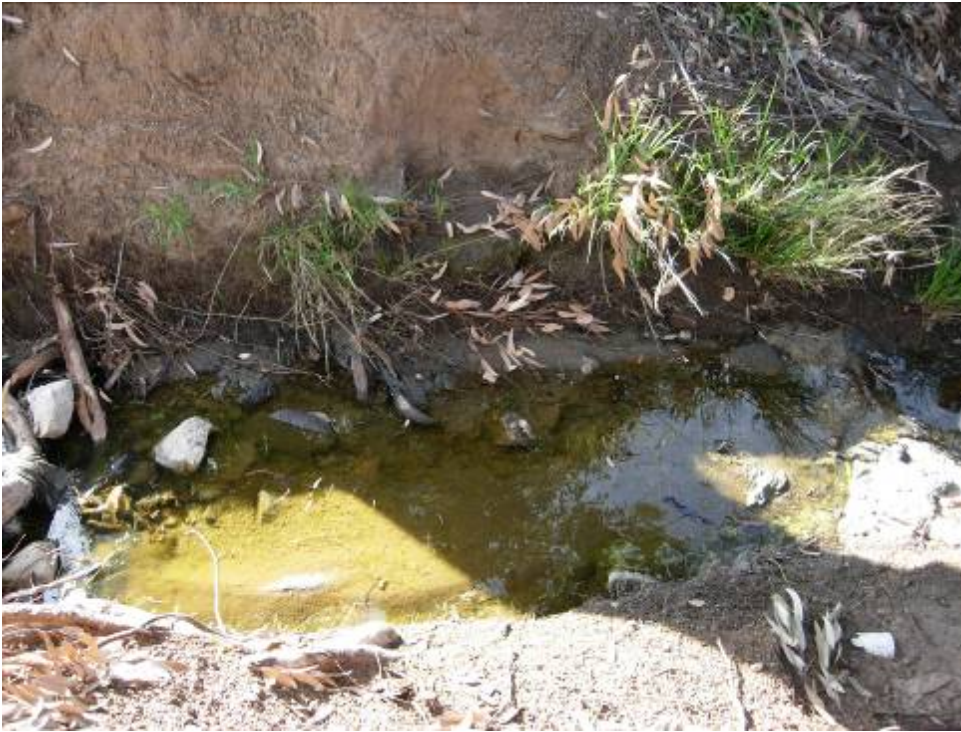
Photograph #3

Photograph is looking south at the channel from the northern side of the channel. The darker line on the bank shows the OHWM. The OHWM is approximately 4' wide.

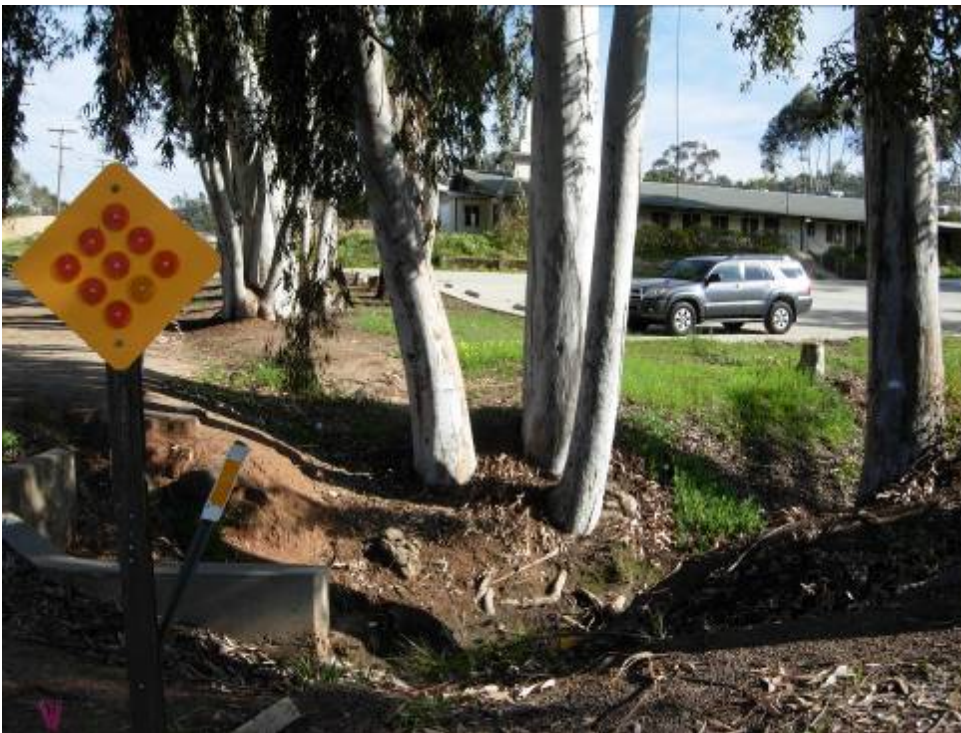
Photograph #4

Photograph is looking at culvert but from the southern side of the channel. Photograph shows the Eucalyptus trees surrounding the channel.

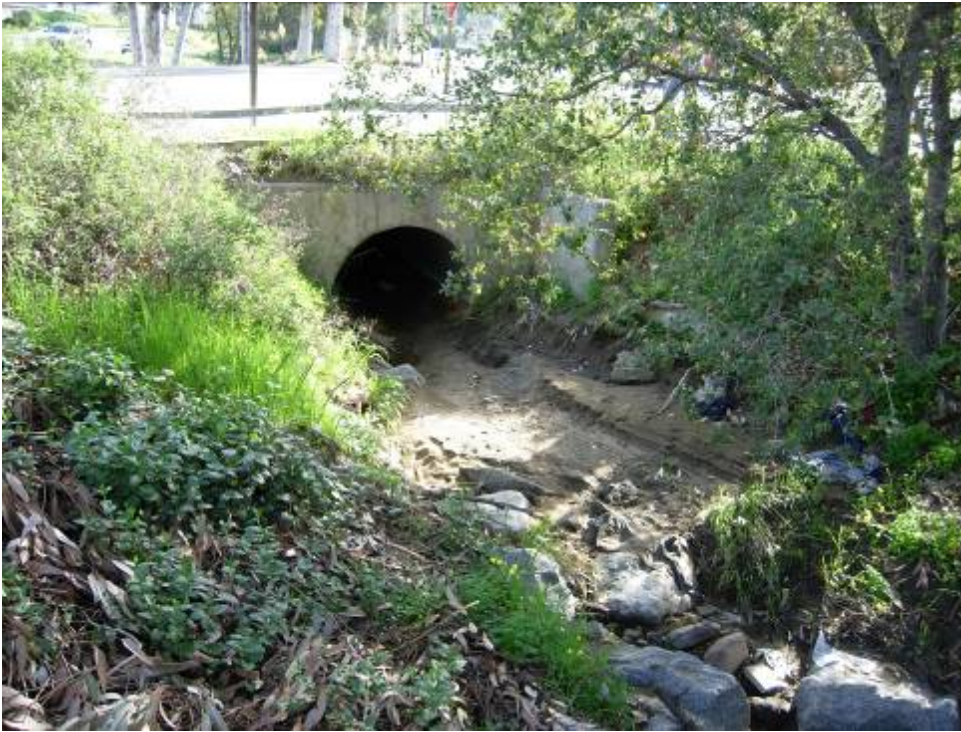
Photograph #5

Shows the culvert that is located on the West side of Tavern Road. The OHWM is approximately 3' wide at the culvert. The photographer is standing on the North side of the channel.

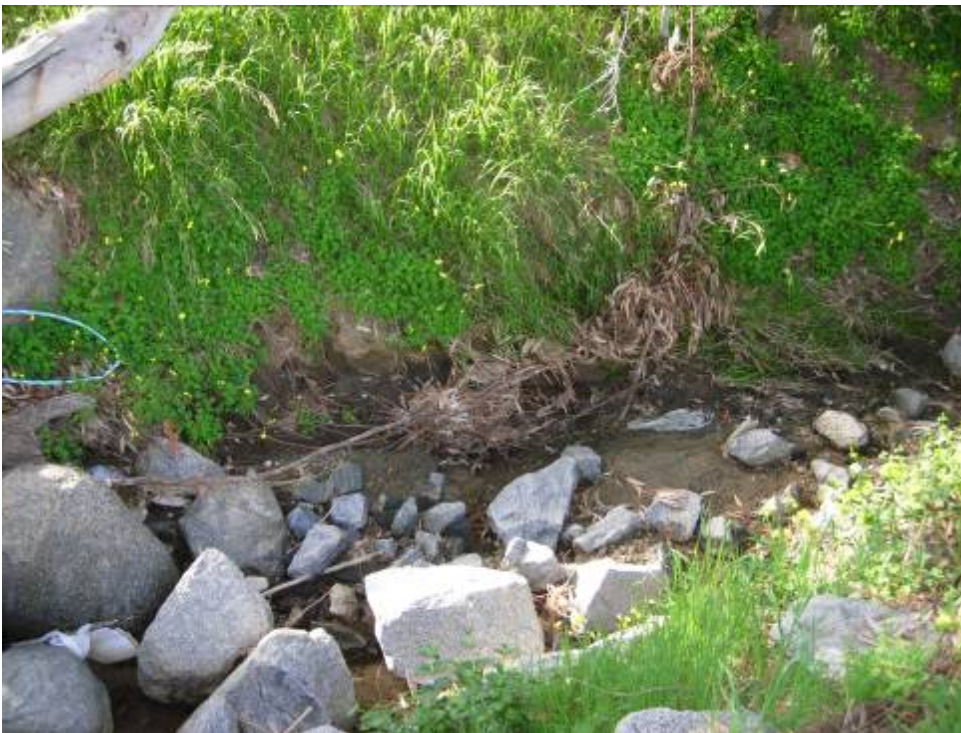
Photograph #6

Area where the rip rap narrows and reduces in size along the channel.

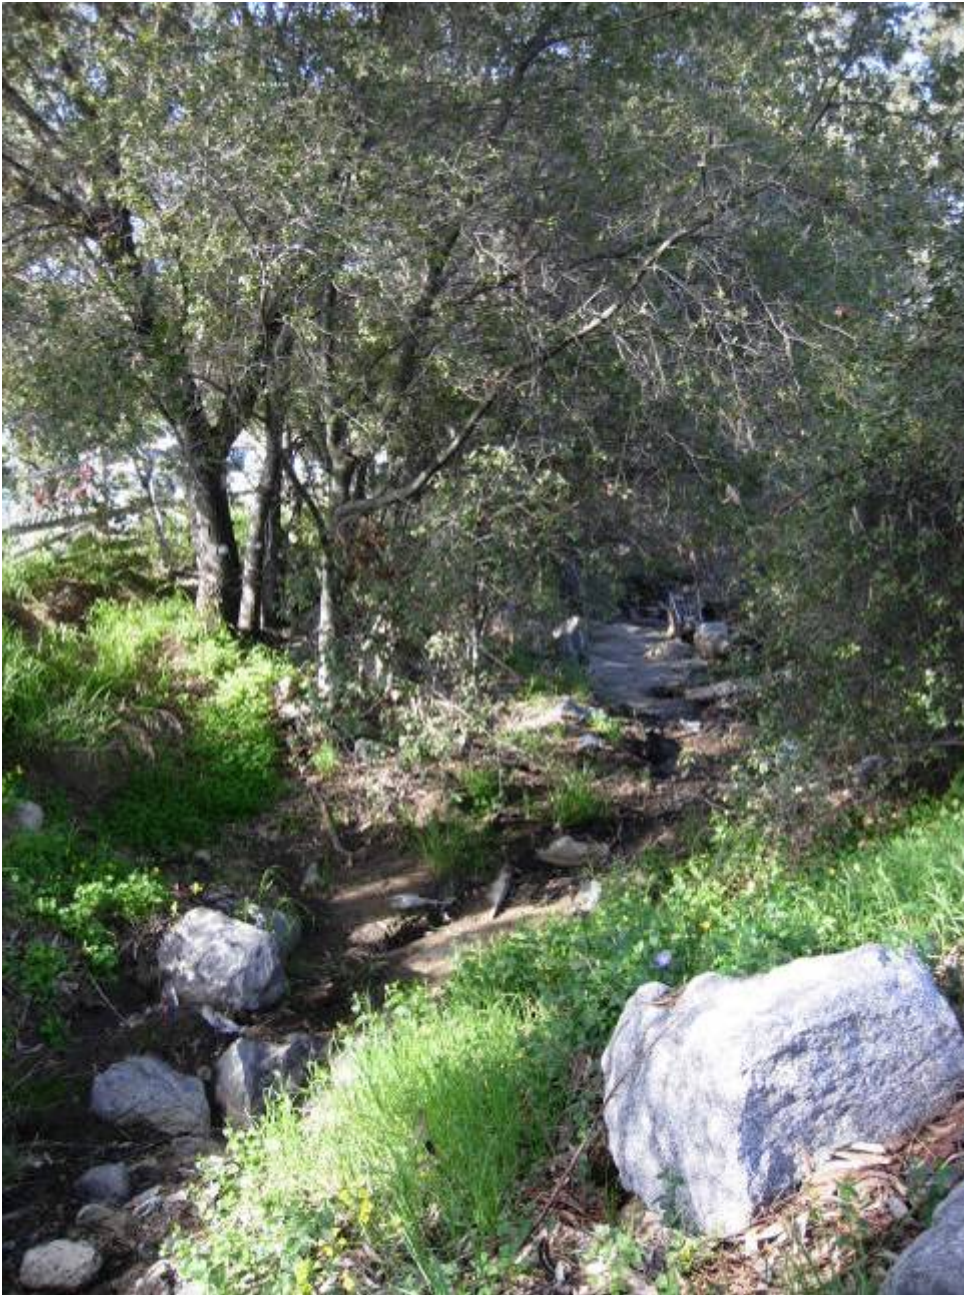
Photograph #7

Photograph of the banks that are approximately 5' wide and 2-3' deep.

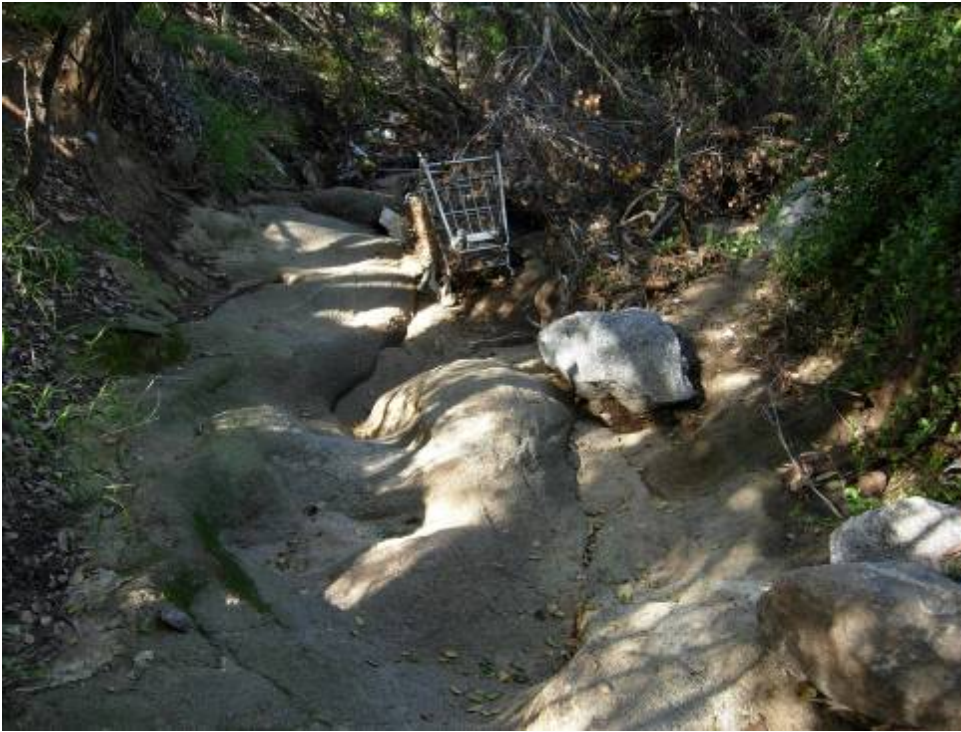
Photograph #8

Shows that there is rock bottom in the channel at about 60' from the culvert.

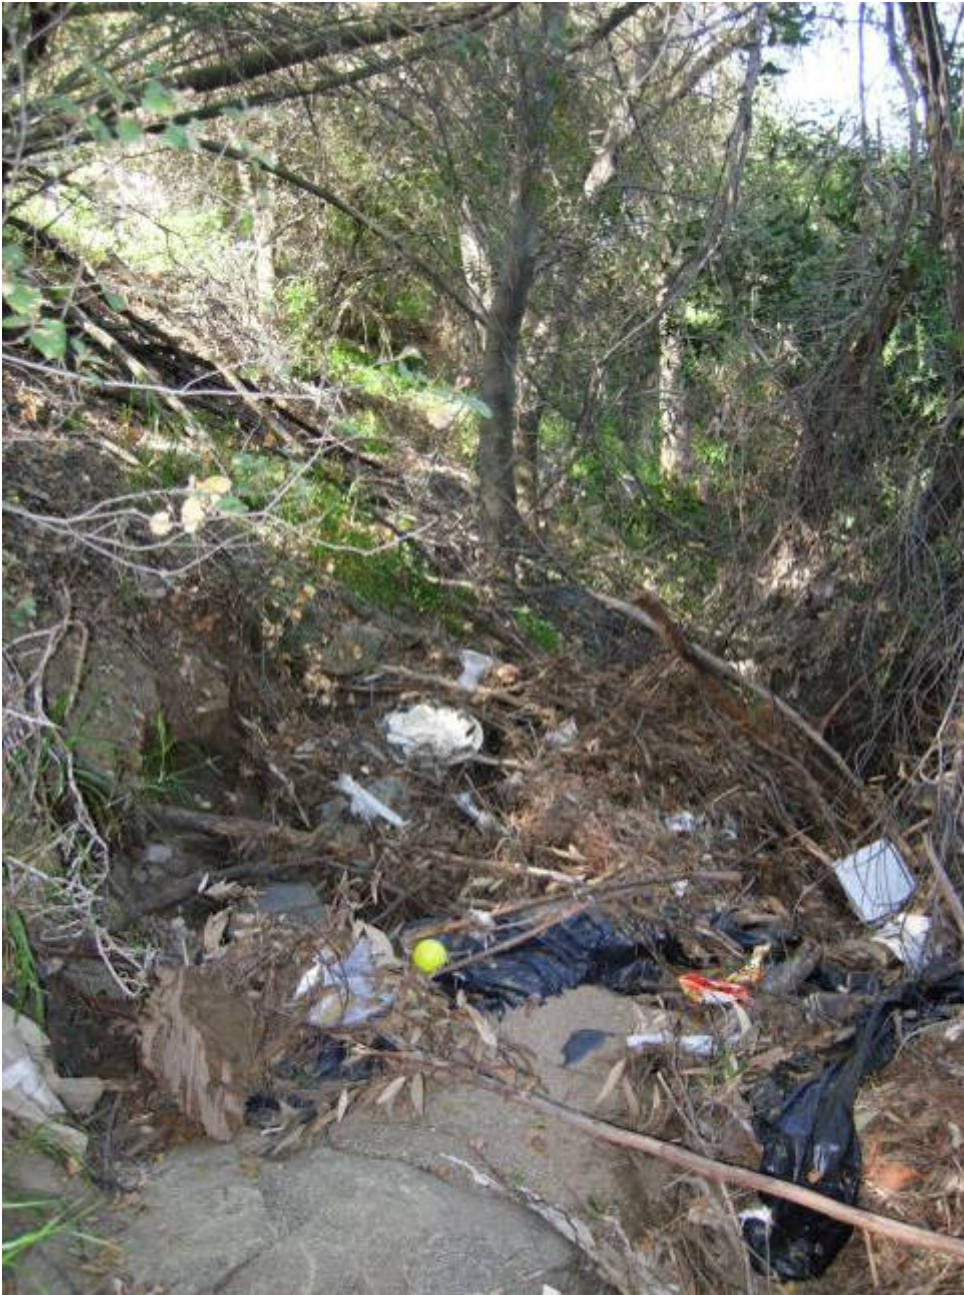
Photograph #9

Shows the increase in debris as move further into OWUS.

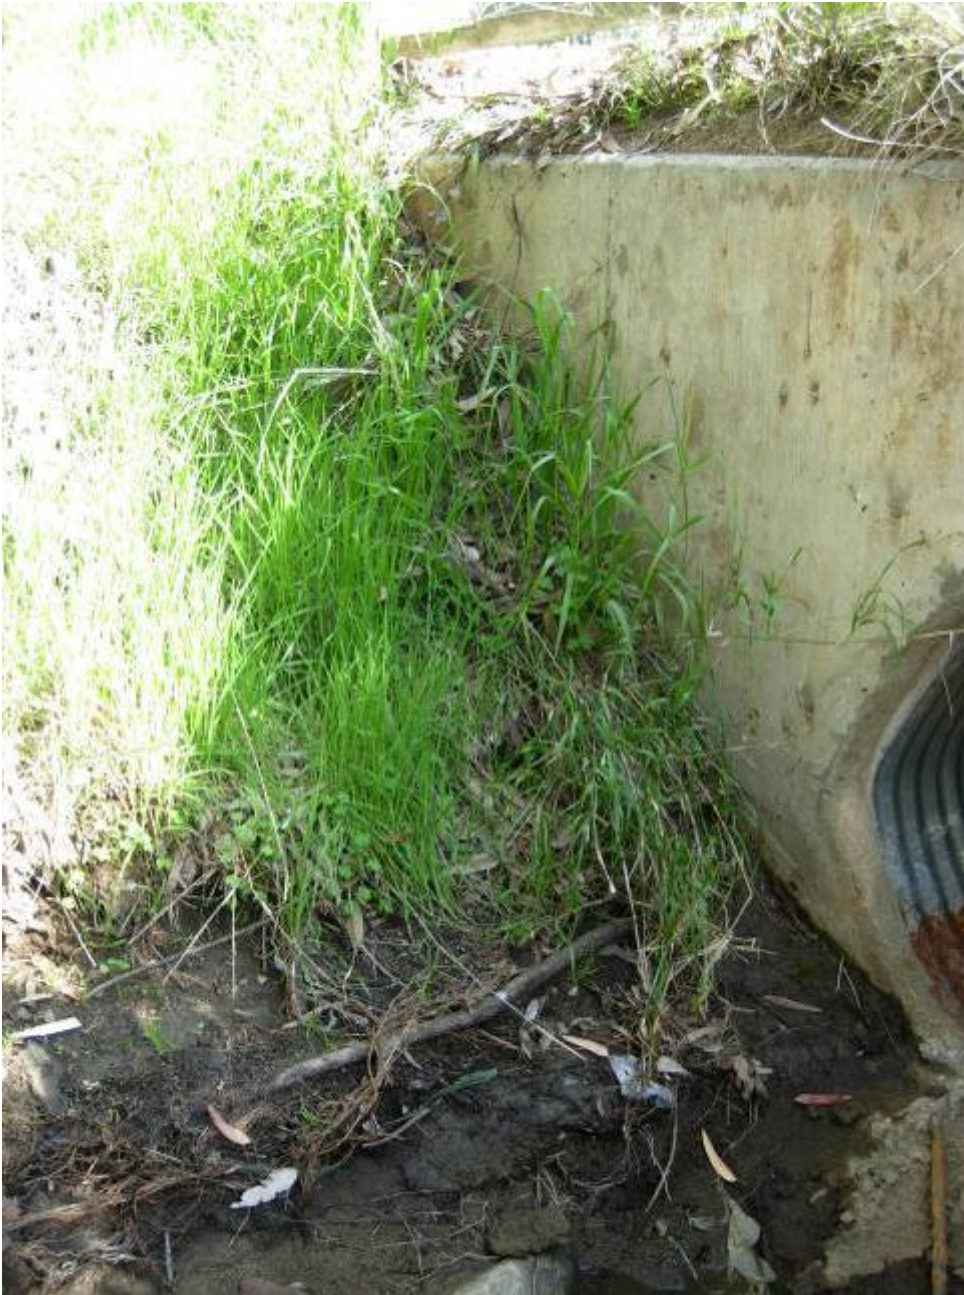
Photograph #10

Photographer is standing in the channel and looking at slope of the bank on the northern side of the culvert.

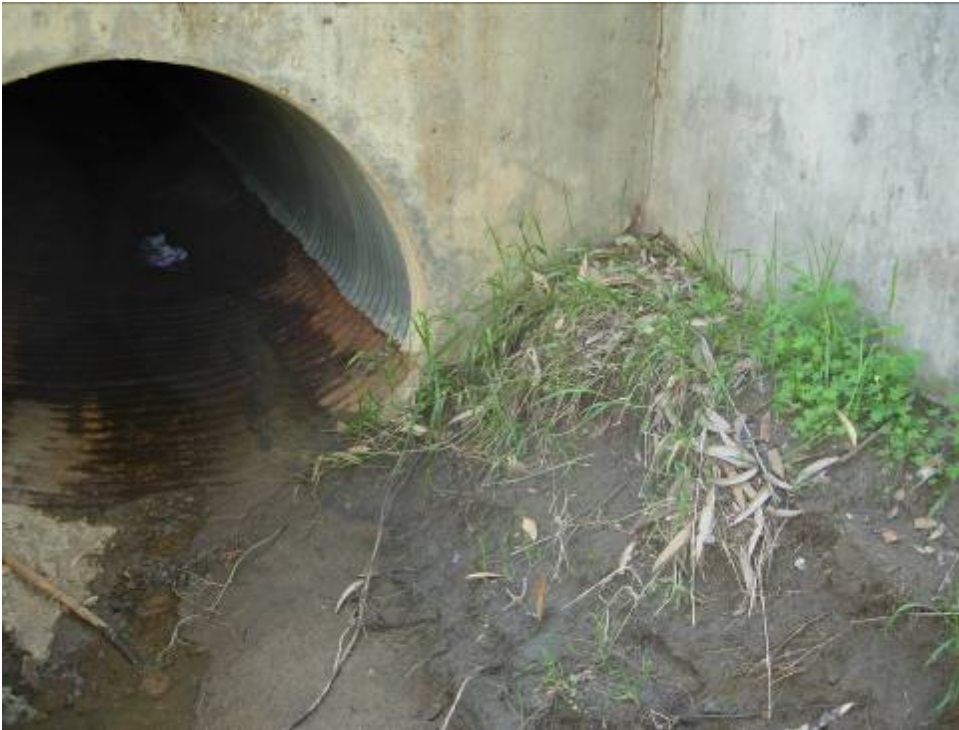
Photograph #11

Near the culvert, there is fill material at the soil surface.

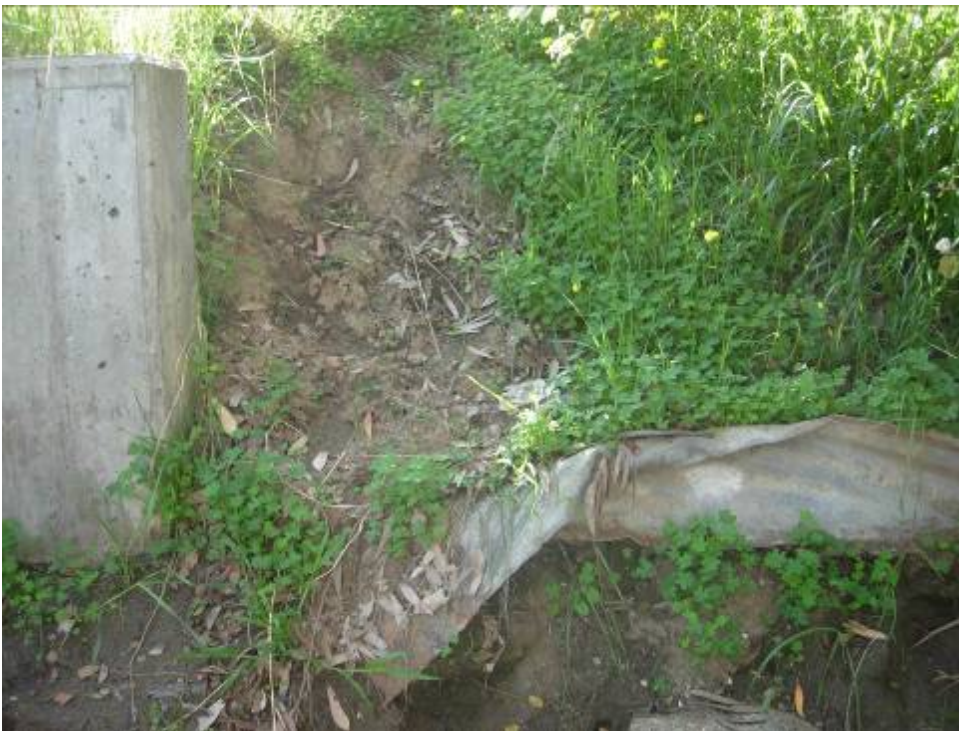
Photograph #12

Photographer is standing in the channel and looking at slope of the bank on the southern side of the culvert.

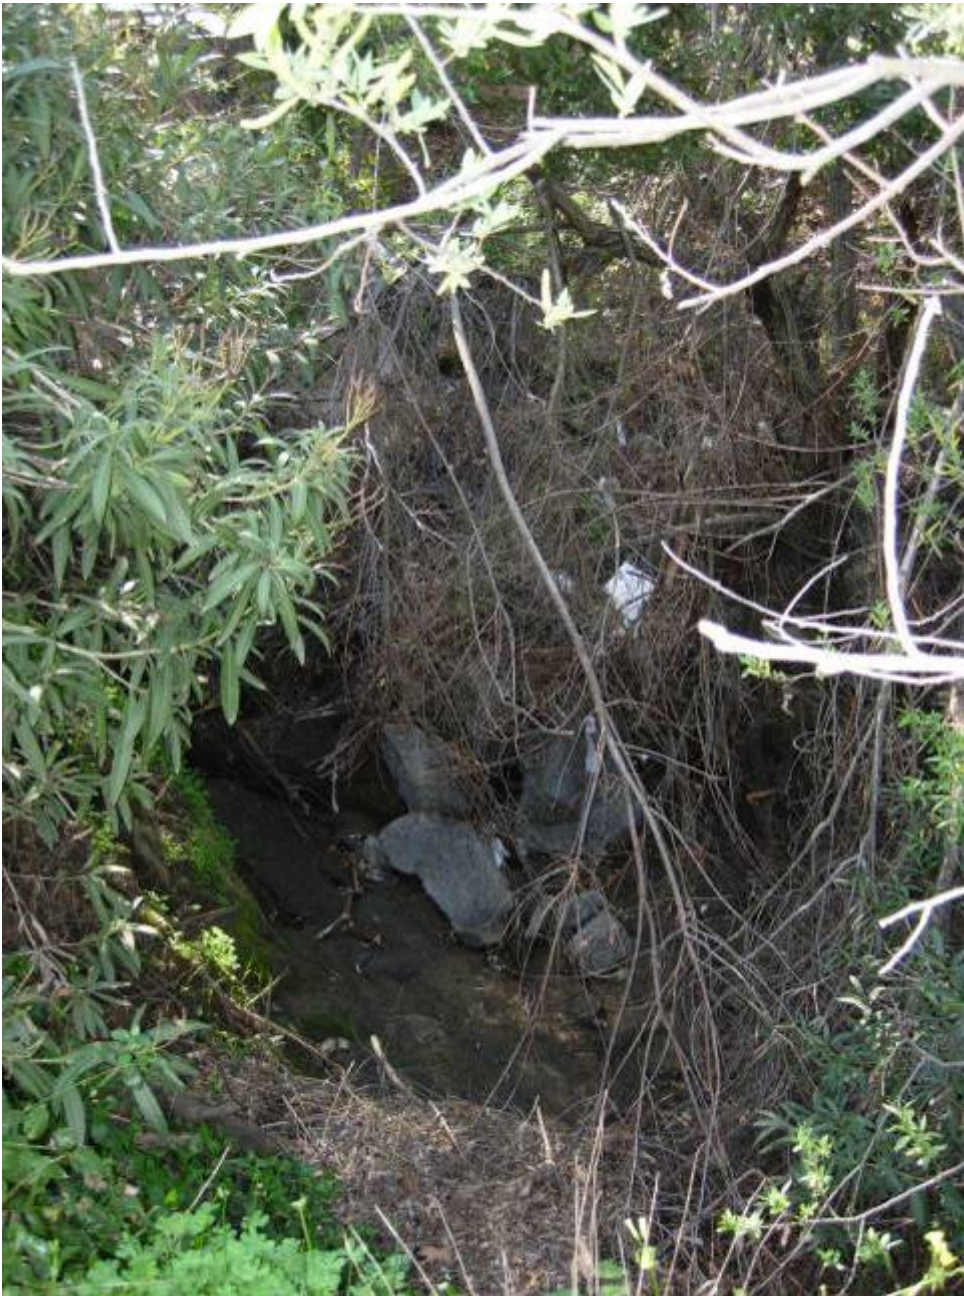
Photograph #13

Shows that the channel changes from rock bottom to silty bottom. The banks are approximately 12' wide with 3' wide OHWM.

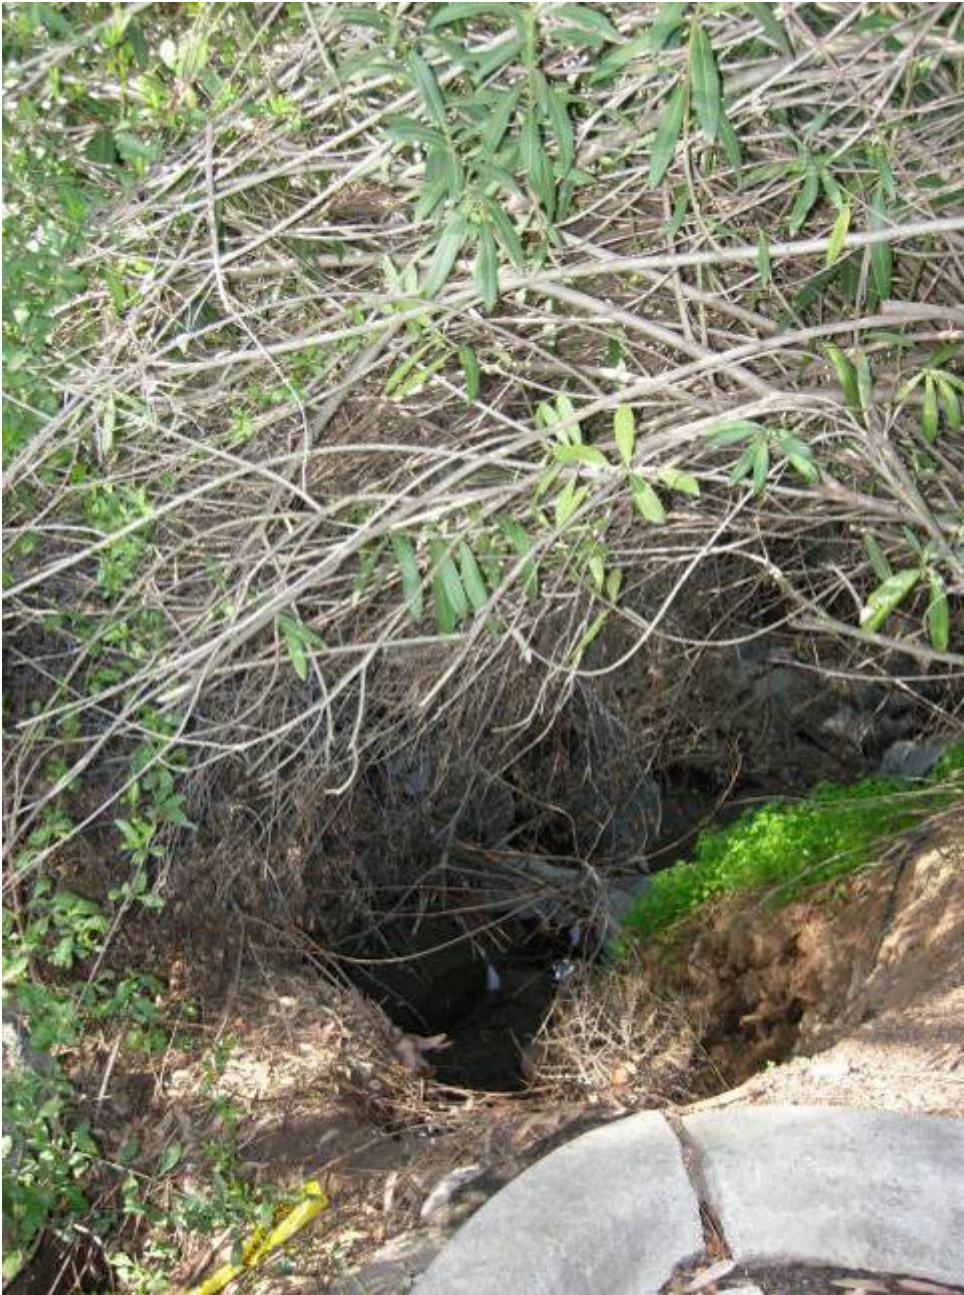
Photograph #14

Photographer is standing near west end of parking lot and looking down the approximately 6-8' high banks.

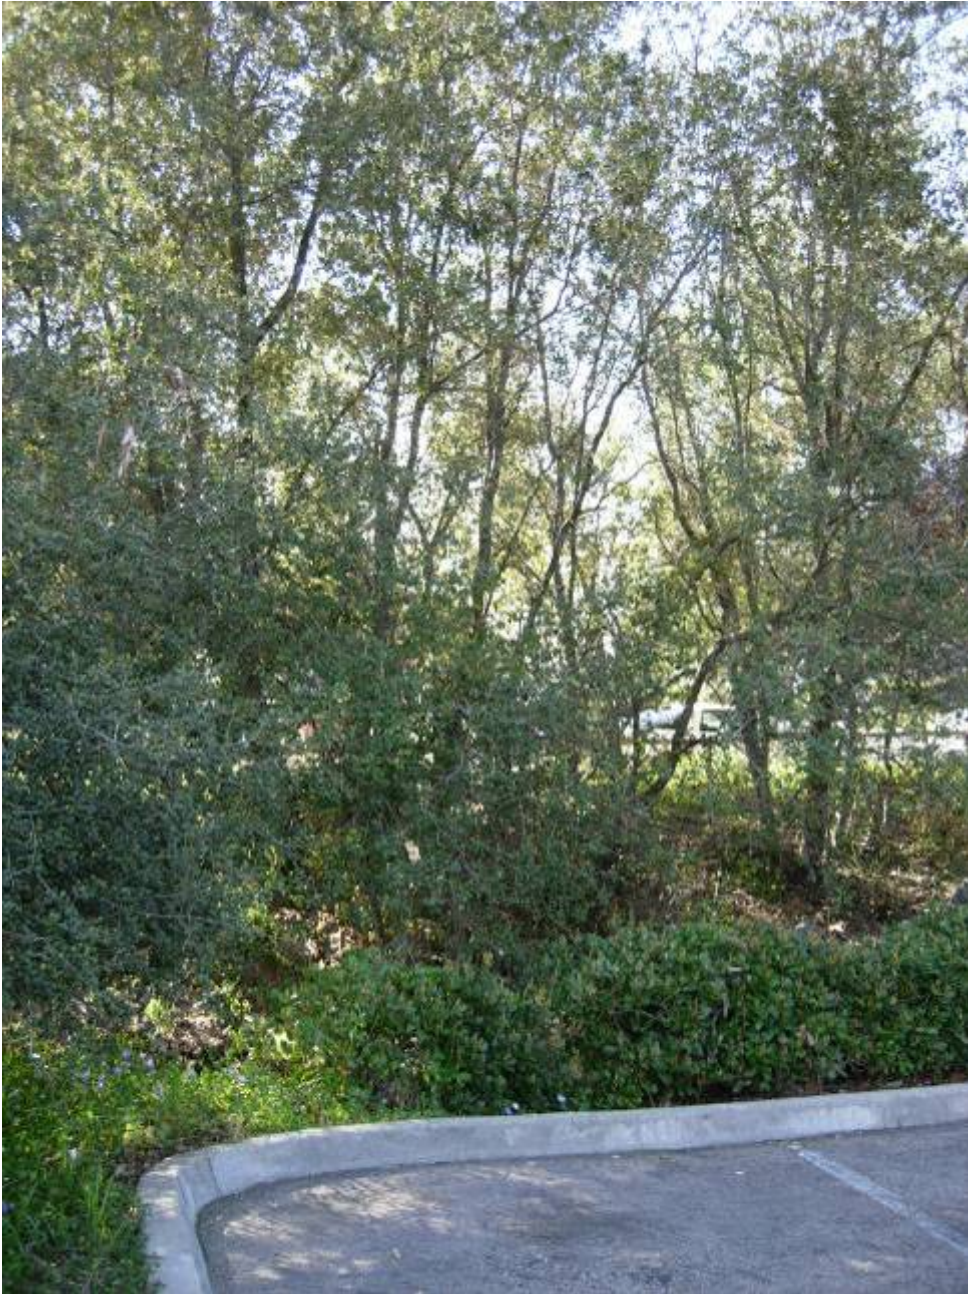
Photograph #15

Shows the parking lot and surrounding areas from the northern side of the channel.

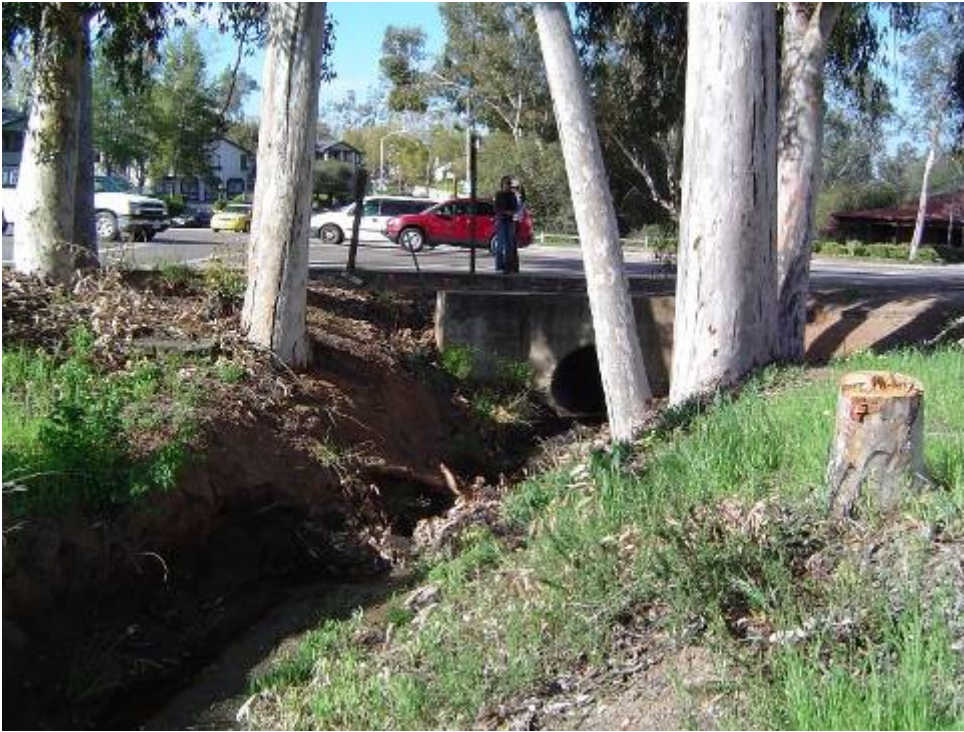
Photograph #16

Landscape view of eastern side of culvert showing eucalyptus trees and weedy vegetation.

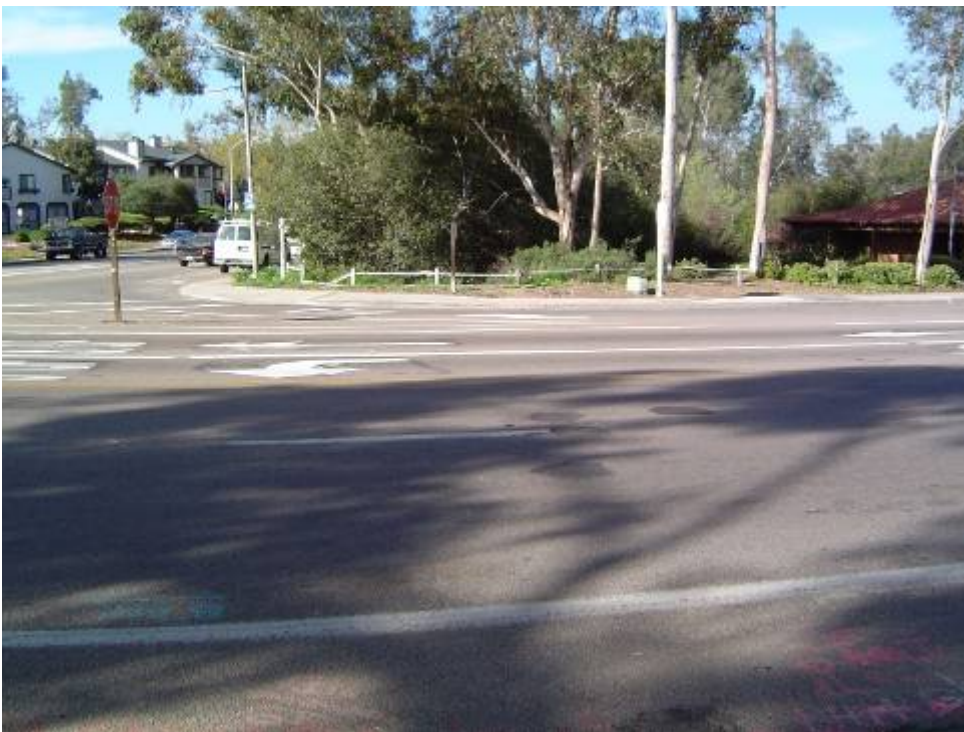
Photograph #17

Landscape view of western side of culvert showing oak trees along Arnold Way, eucalyptus trees, and ornamental vegetation associated with building for sale.
